**An Aquatic Plant Management Plan Update For
Delavan Lake
Walworth County, WI**

2017

Delavan Lake Sanitary District

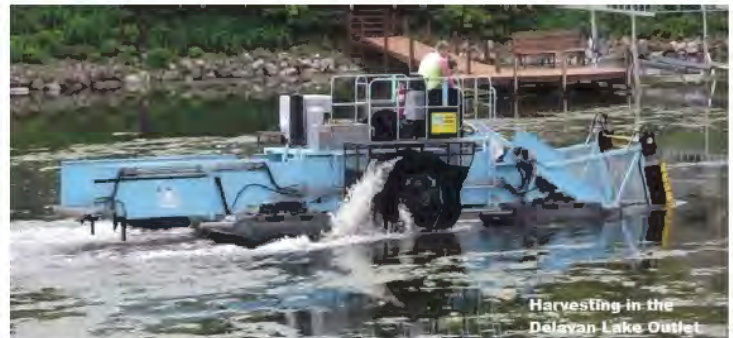
The Delavan Lake Sanitary District mechanical harvesting equipment includes three harvesters, one high-speed transport barge, three off-loading shore conveyors, one dump truck and three other support vehicles. The maximum cutting width ranges from 7 feet for the two larger harvesters to five feet for the smallest harvester. Each of the three harvesters is capable of harvesting plants up to a maximum depth of five feet.

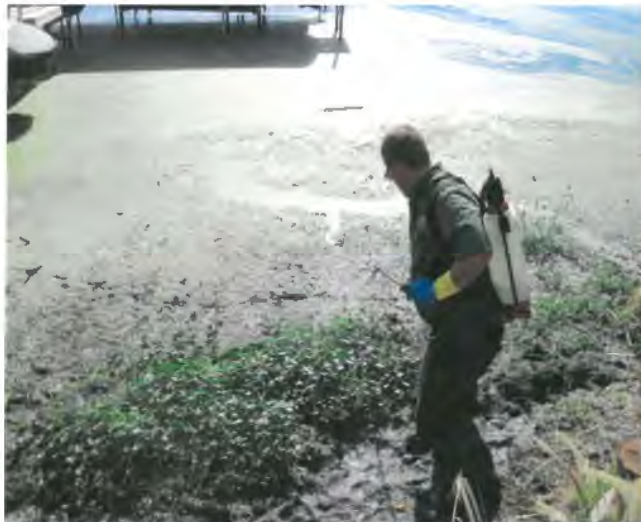
Chemical Treatment of Pennywort

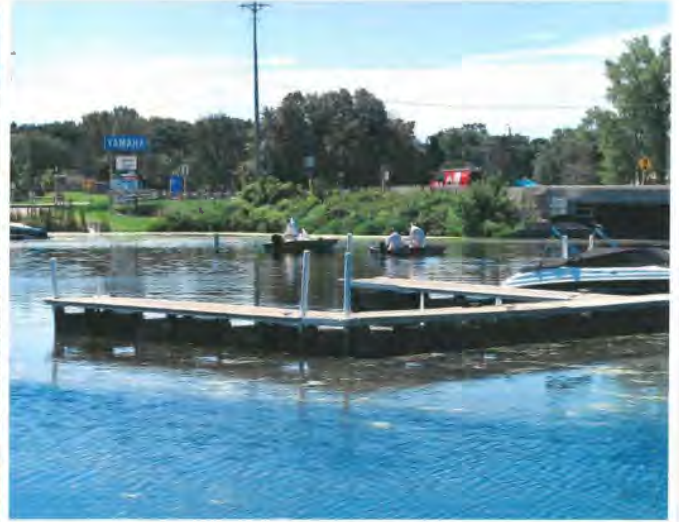
Chemical Treatment of Shallow Areas

Chemical treatment of non-native nuisance aquatic plants is recommended for areas that are too shallow for mechanical harvesting. Chemical treatment should be limited to controlling nuisance growths of AIS, especially Eurasian water milfoil, Curly leaf pondweed and Water pennywort. Chemicals that offer some selectivity such as 2,4-D and Endothall should be considered for control of Eurasian water milfoil and Curly leaf pondweed. Early spring and late fall applications may provide good control while protecting native species. Chemical treatment may also be considered for any newly discovered AIS.

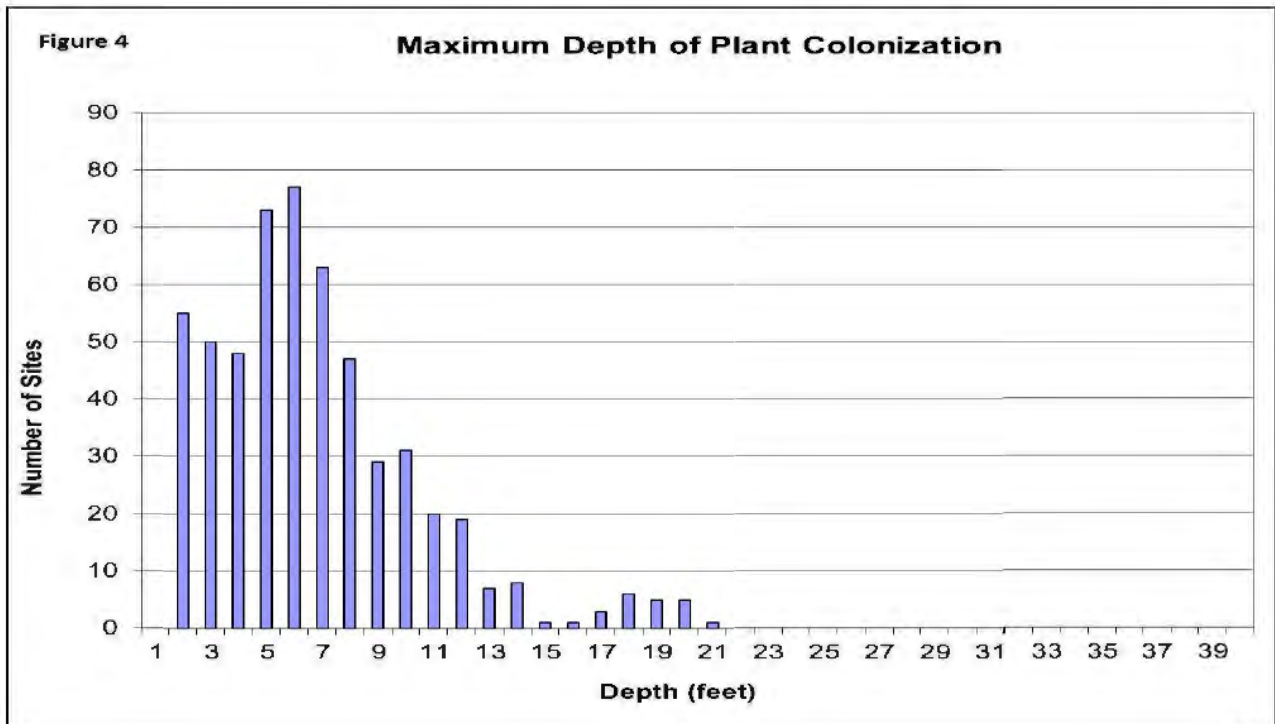
Maximum Depth of Plants: (Figure 4) Shows plant occurrences by water depth. This can be an especially important parameter to use when comparing surveys from different years because if water quality and clarity decrease, without a change in overall water depths, it may indicate a decline in water quality.

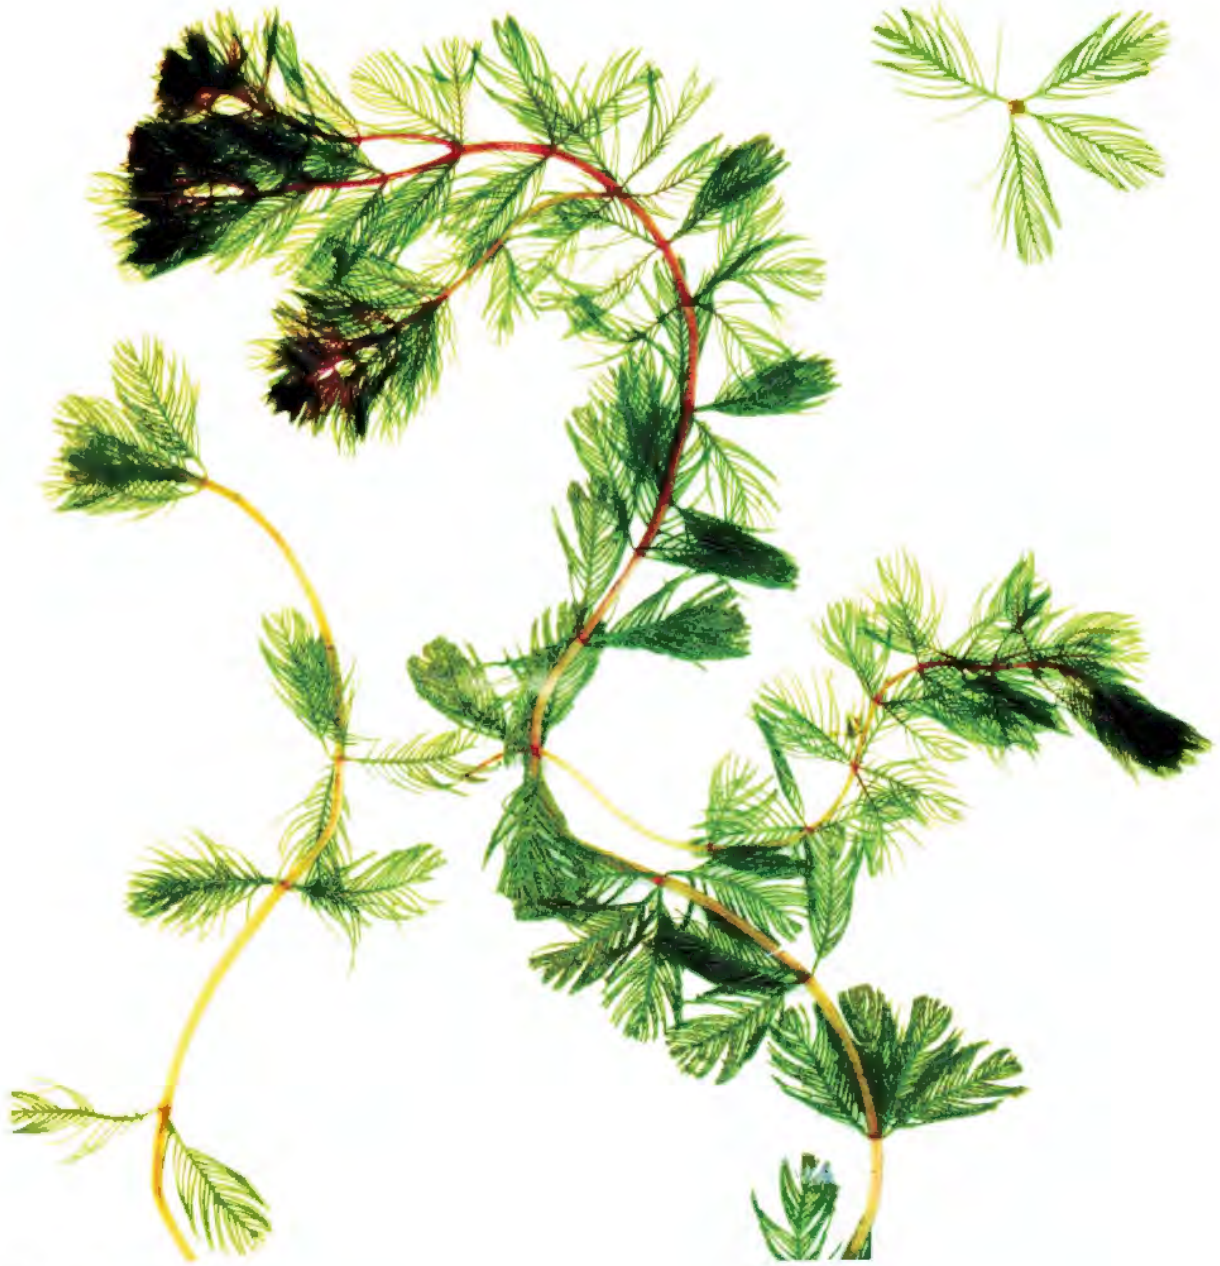
MAP 6
2015 Eurasian Water Milfoil Locations

Eurasian Water Milfoil
Source: SEWRPC

Although statistics can not be compared between the 2015 and earlier surveys, Eurasian water milfoil and Coontail were considered the dominate aquatic plants found in Delavan Lake during those earlier surveys and the 2015 aquatic plant survey shows that they are still dominate species. Survey reports from 2008 through 2013 also state that the Chara population was declining. The 2015 survey results show that Chara was only found in 65 sites in the lake with the majority found in the outlet and in the North lobe of the South end of the lake. The 2008 survey report suggests that the high levels of filamentous algae may be at least partially responsible for the decline in Chara²⁰. It is recommended that Delavan Lake be sampled every 3-5 year intervals and using the same sampling protocol Recommended Baseline Monitoring of Aquatic Plants in Wisconsin: Sampling Design, field and Laboratory Procedures, Data Entry and Analysis, and Applications,(Rev. March 2010).

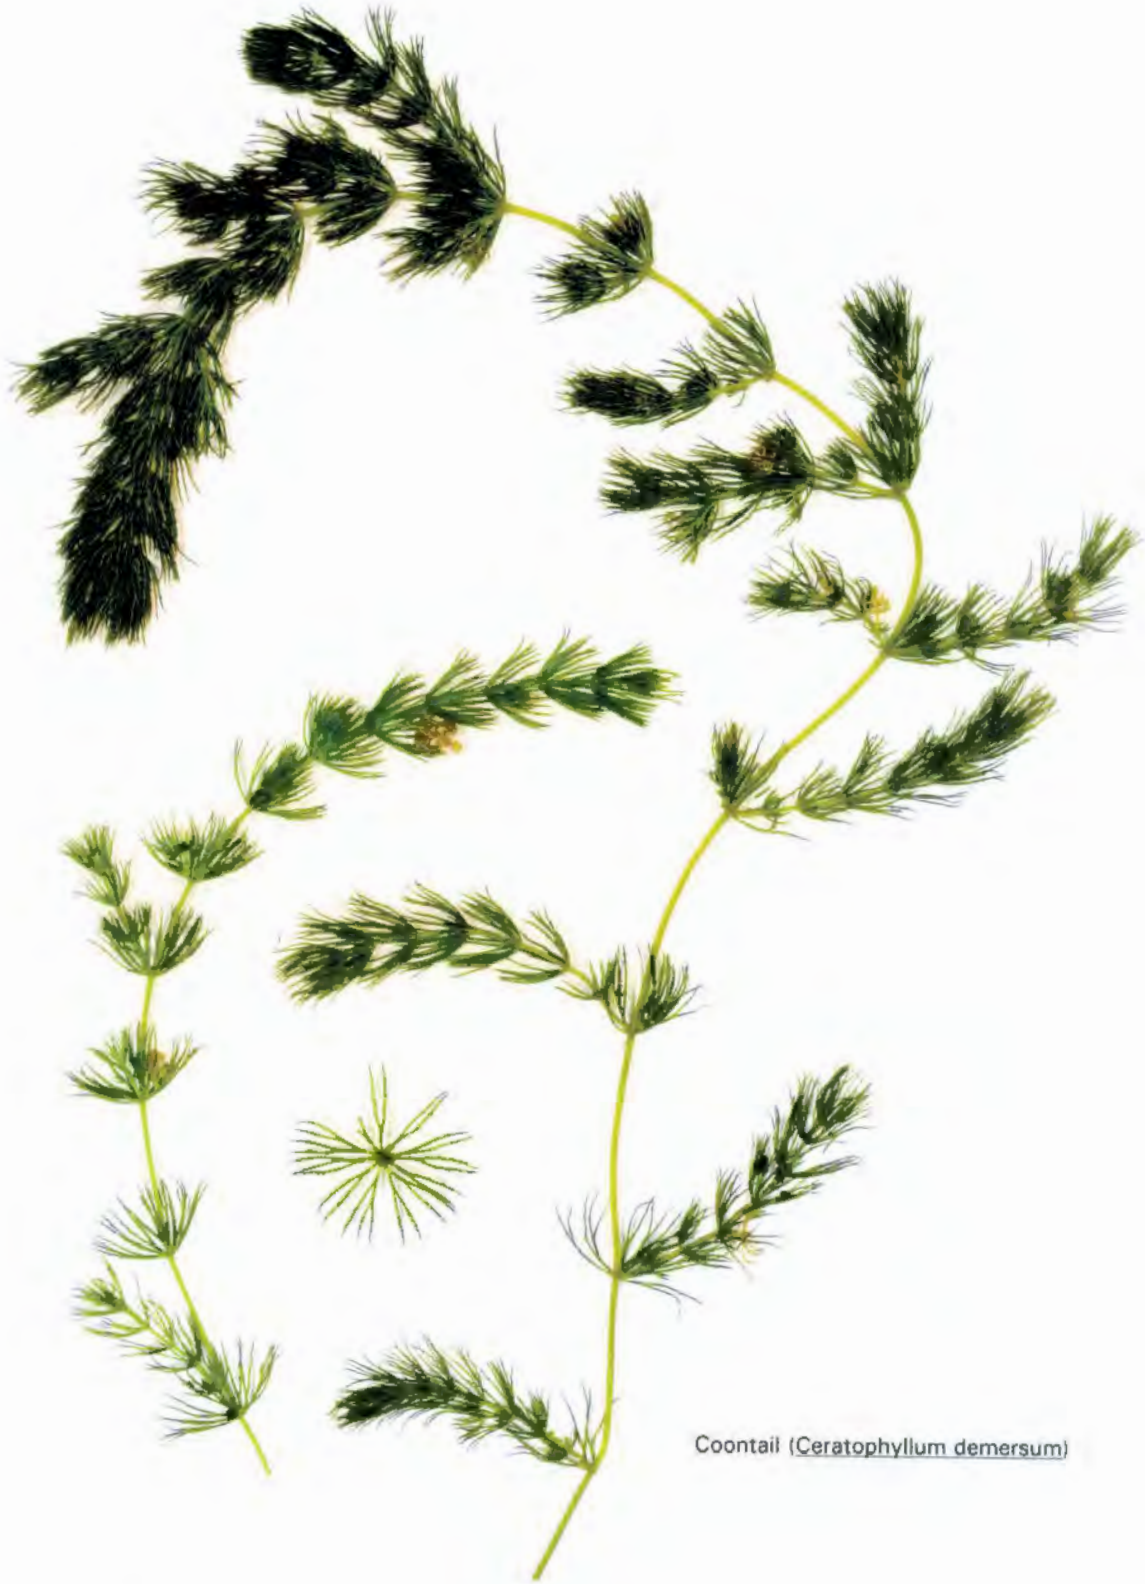
Coontail (Ceratophyllum demersum)

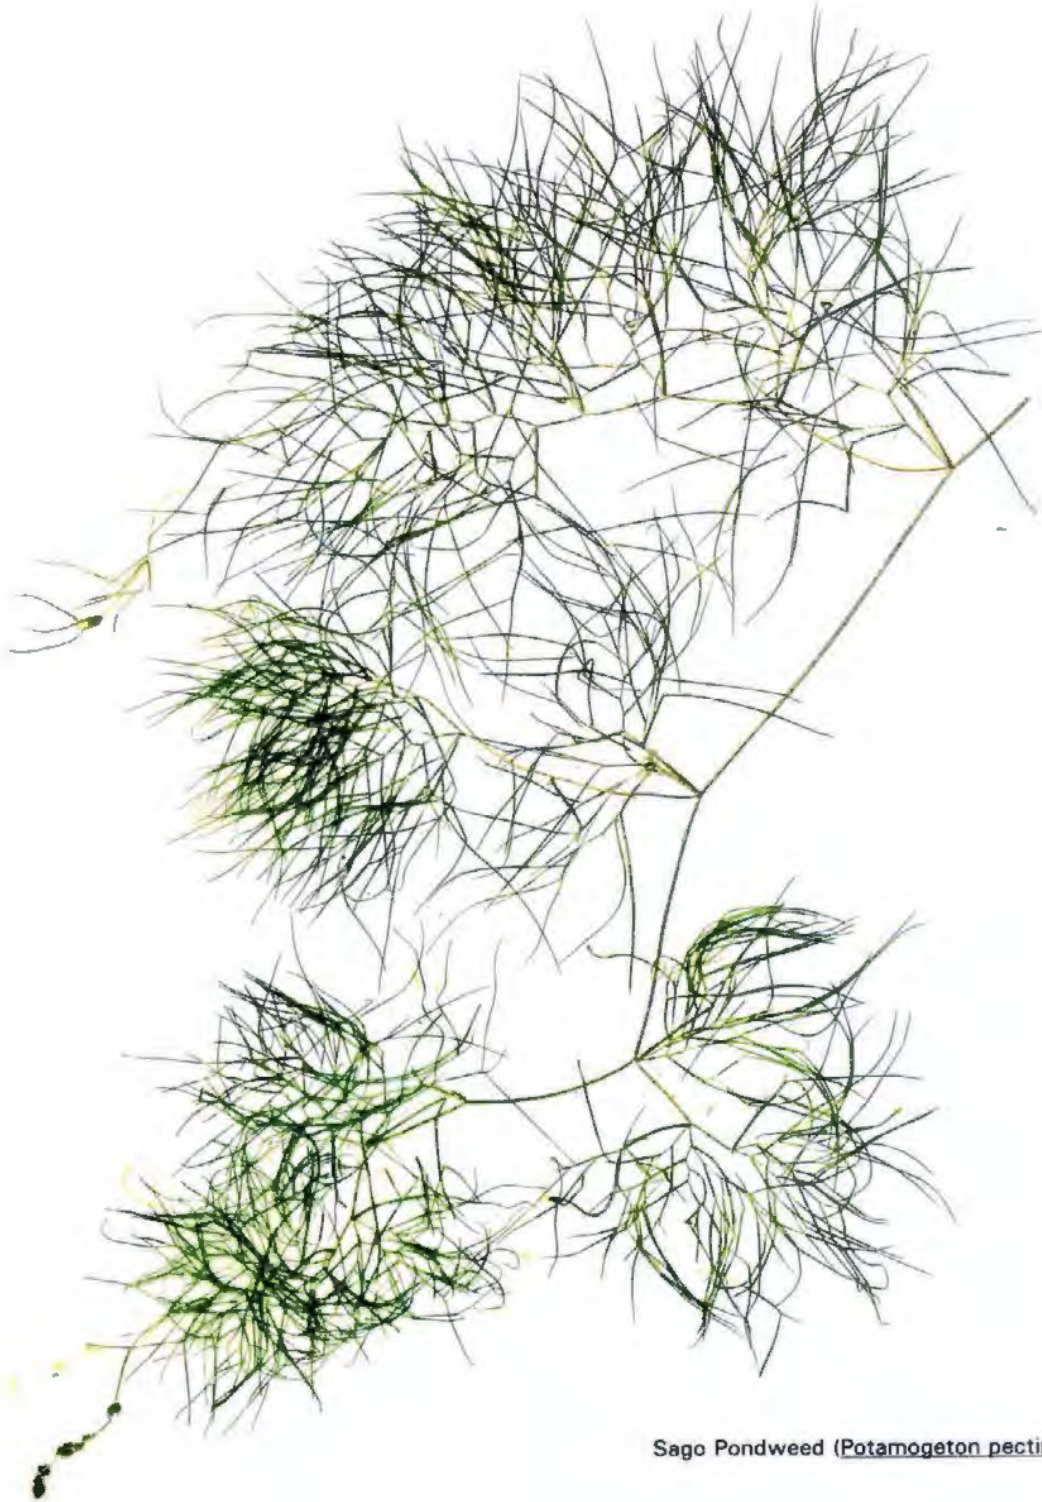
MAP 9
2015 Sago Pondweed Locations

Sago Pondweed (*Potamogeton pectinatus*)

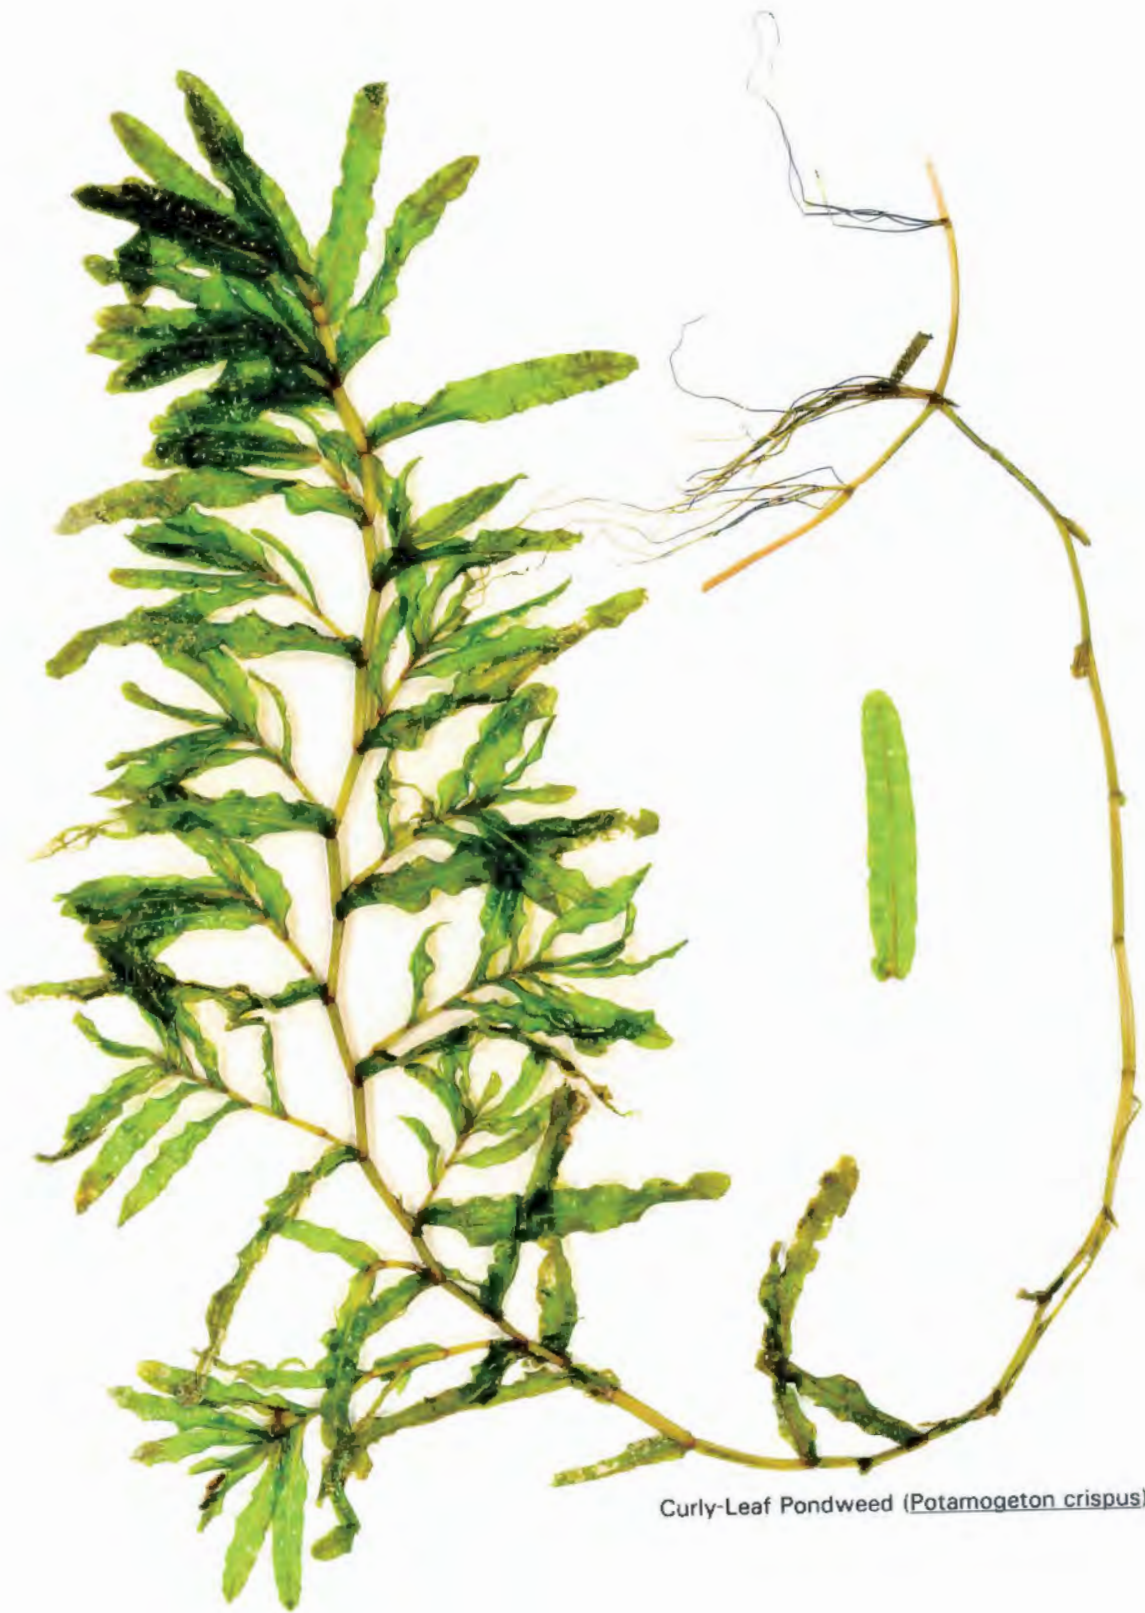
MAP 12
2015 Curly leaf Pondweed Locations

Curly-Leaf Pondweed (*Potamogeton crispus*)

Eurasian water milfoil and Curly leaf pondweed were the only non-native invasive species that were sampled. Curly leaf pondweed (Map 12) was only sampled at 31 sites and all in the Northern portion of the lake. However, the survey was conducted in late July which is after the average Curly leaf pondweed growing cycle. It may be necessary to conduct an aquatic plant survey earlier in the season on some years in order to achieve a good Curly leaf pondweed population assessment. There are also several other AIS that have been found in or near Delavan Lake. Water Pennywort was likely not sampled because it is generally not seen until late August and September. It is recommended that monitoring for AIS be continued. It is also recommended that public education concerning AIS and AIS monitoring be continued. It is also recommended that DLSD staff continue to work with volunteers who wish to assist with AIS monitoring. In addition, it is recommended that the Town of Delavan work with the Delavan Community Park to continue the Clean Boats, Clean Waters watercraft inspection program to education boaters and anglers about the steps that are required by law to prevent the spread of AIS.
