AQUATIC PLANT MANAGEMENT PLAN UPDATE FOR DELAVAN LAKE

WALWORTH COUNTY, WISCONSIN

SEWRPC MEMORANDUM REPORT
NUMBER 190, 2ND EDITION

July 2022

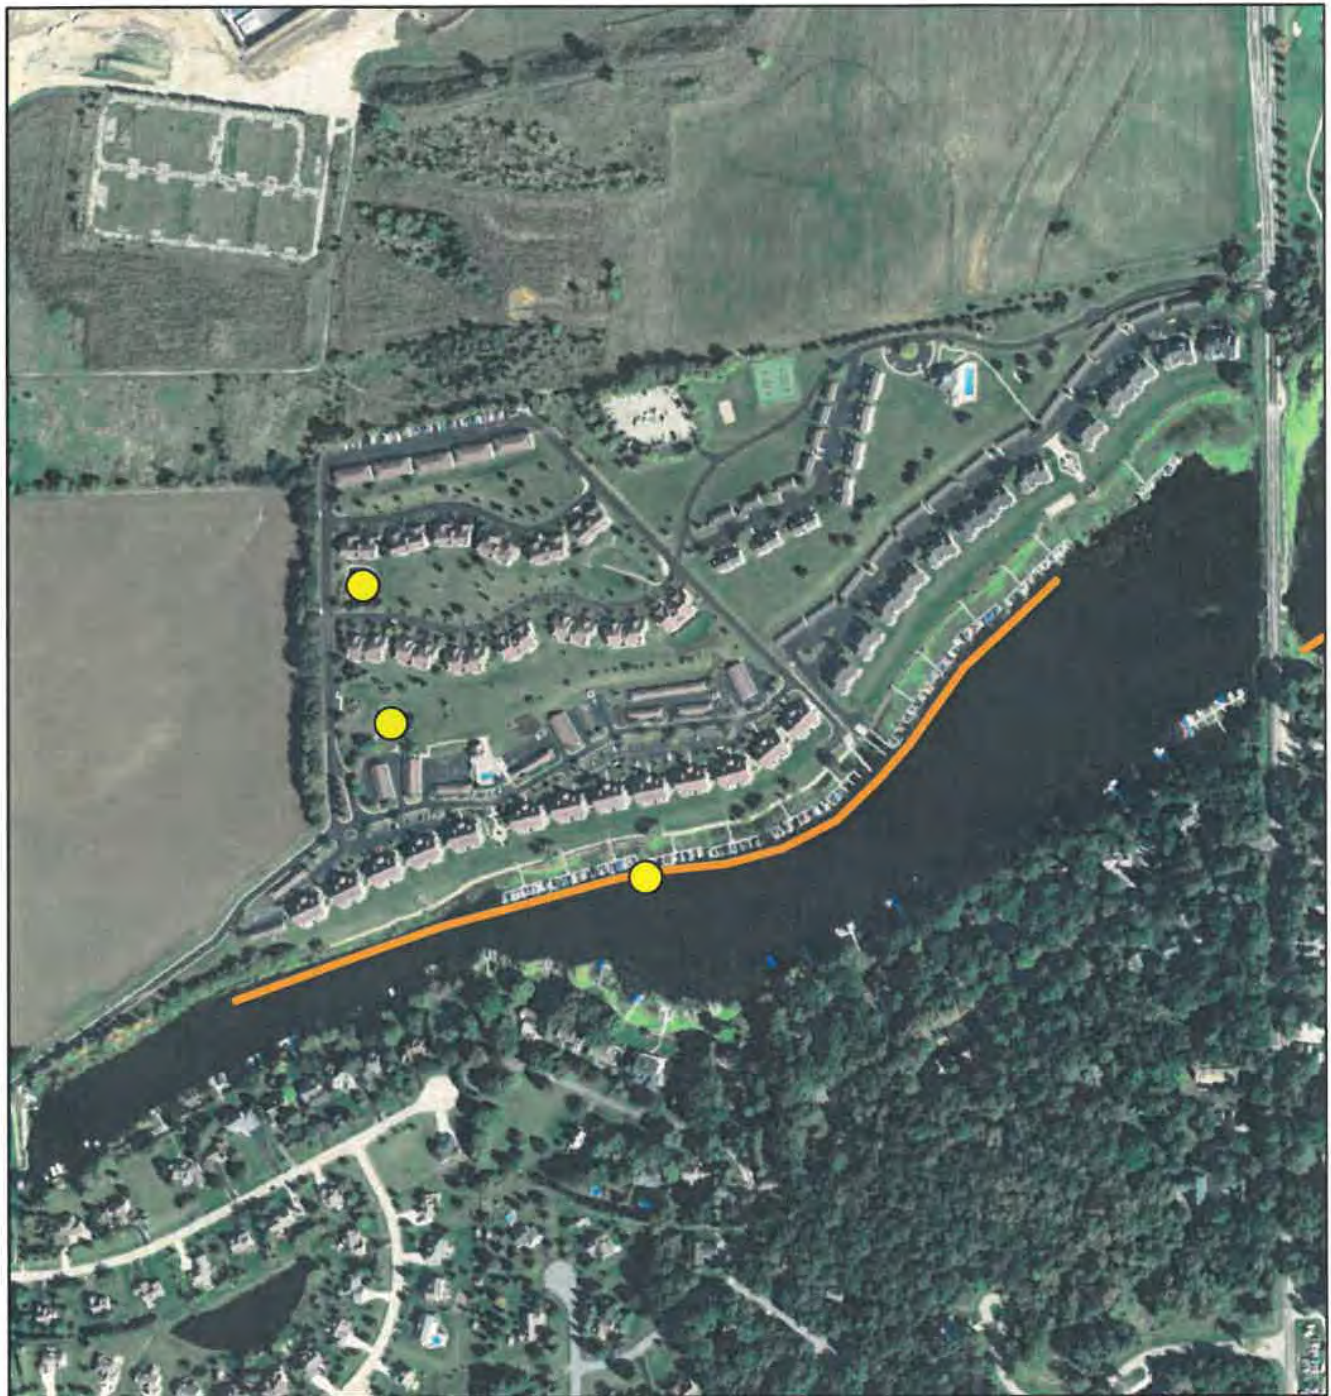
Current Sacred Lotus and Yellow Floating Heart Monitoring Locations on Delavan Lake: 2022

● YELLOW FLOATING HEART MONITORING LOCATION

— SACRED LOTUS MONITORING AREA

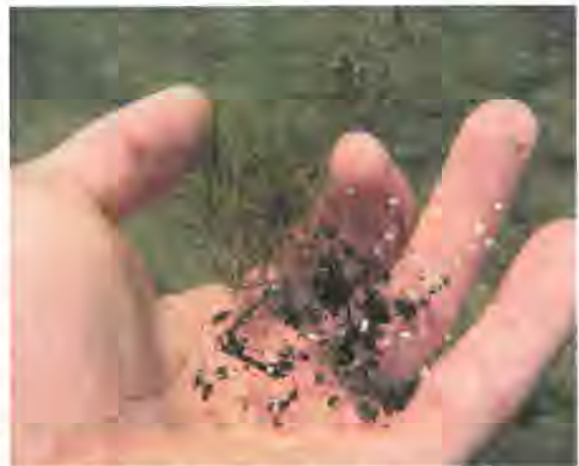
Figure 2.10
Starry Stonewort (*Nitellopsis obtusa*)

Note: Note the small, star-shaped white bulbils

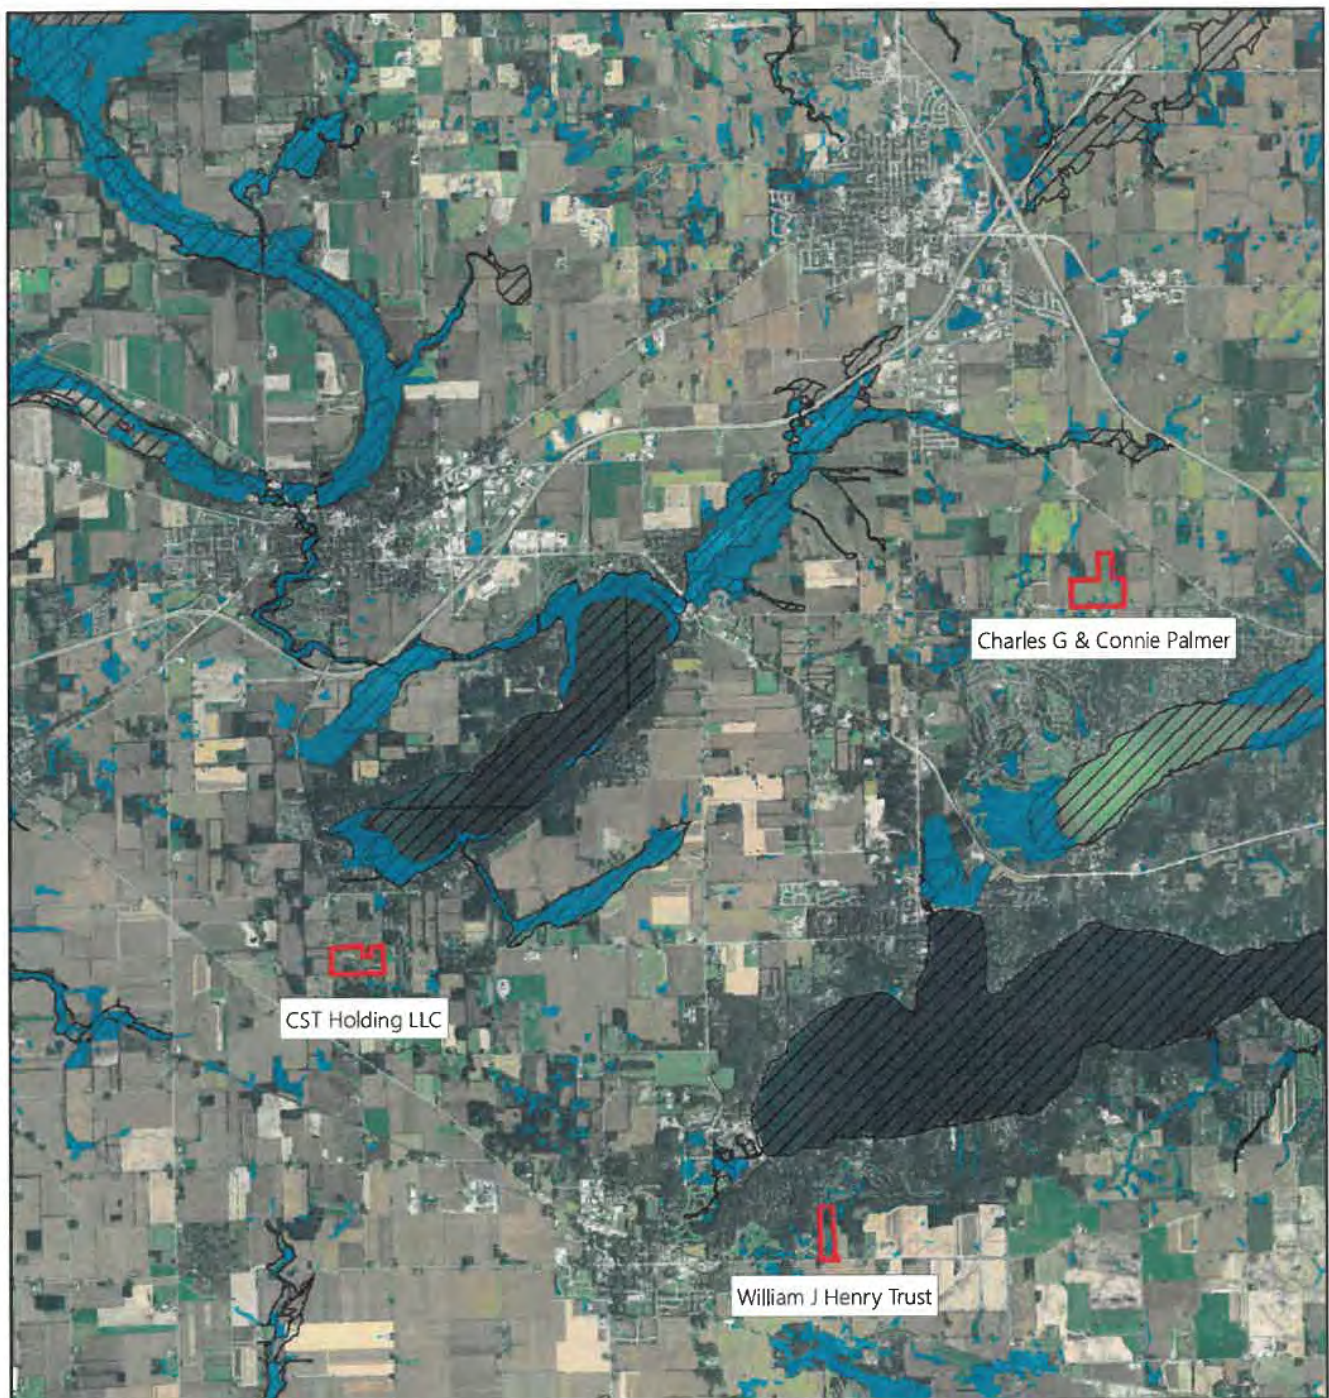
Map 3.1
Delavan Lake Harvested Plant Disposal Sites

- DISPOSAL LOCATION
- IDENTIFIED WETLANDS
- 100-YEAR FLOODPLAIN

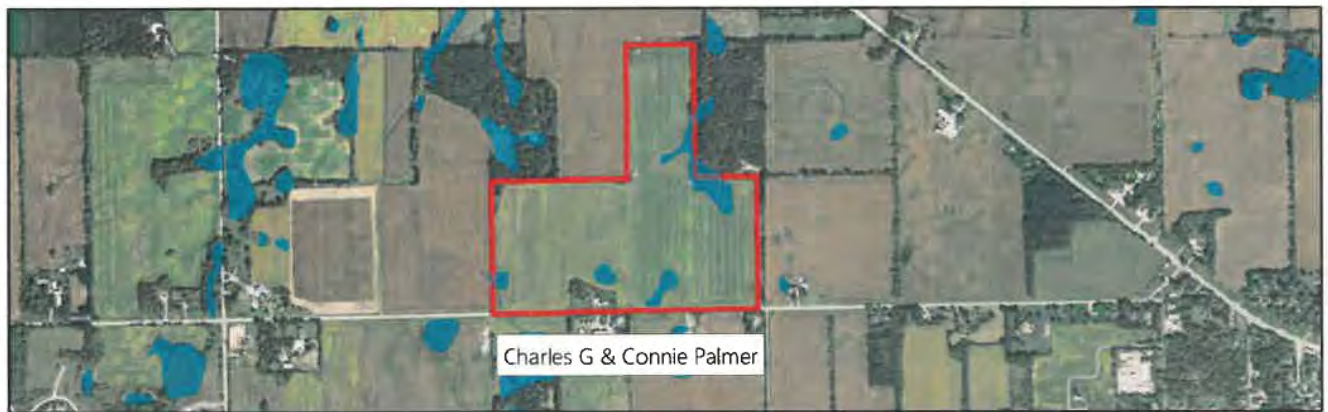
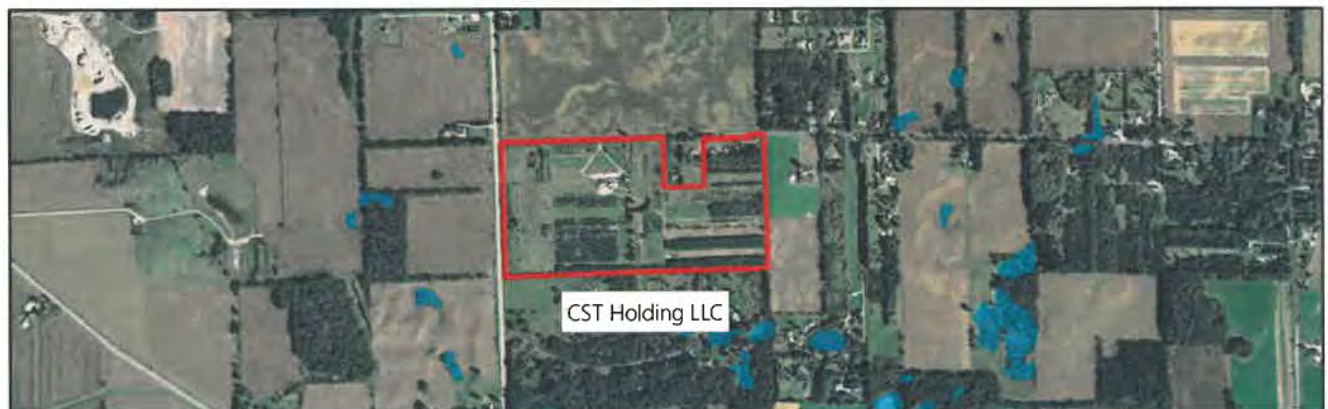
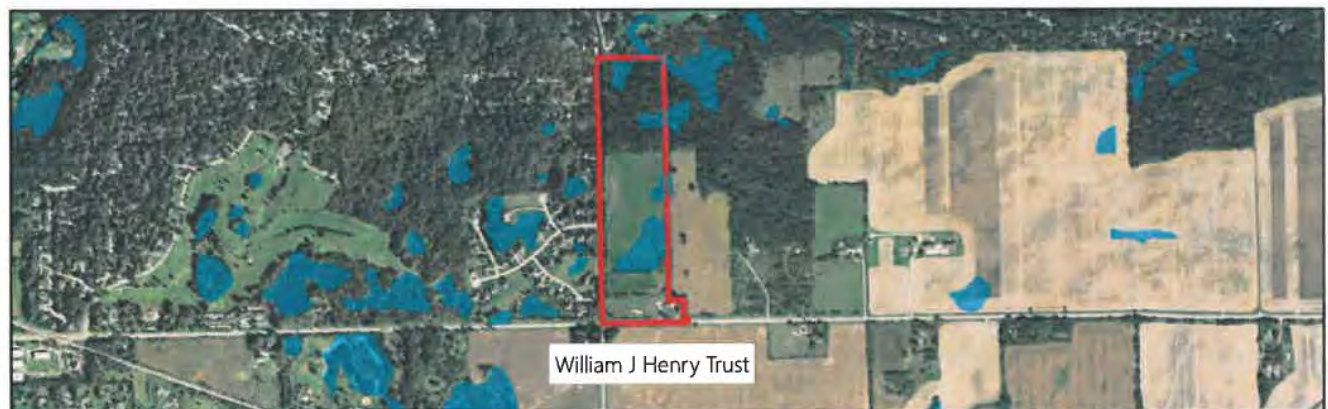
Map 3.2
Delavan Lake Harvested Plant Disposal Sites Continued

-   DISPOSAL LOCATION
-   IDENTIFIED WETLANDS
-   100-YEAR FLOODPLAIN

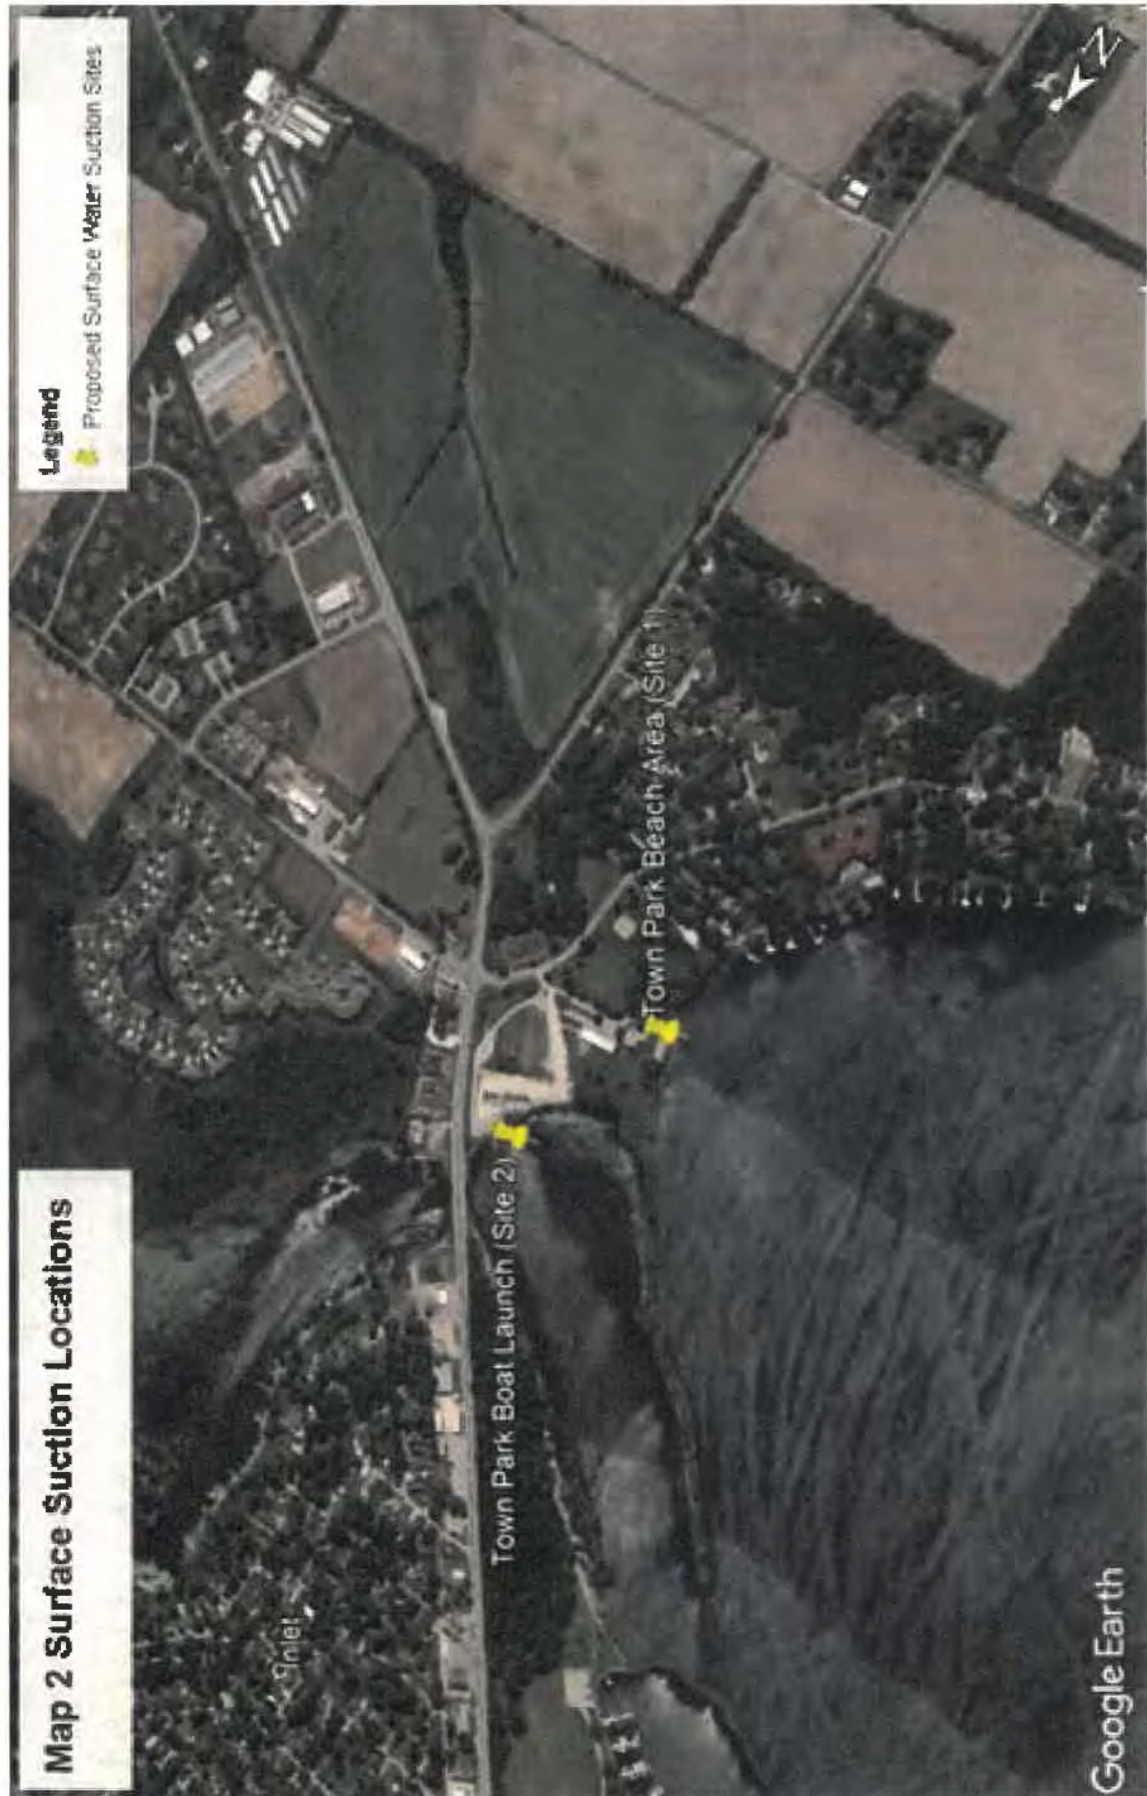
Map C.2
Surface Suction Locations

Surface suctioning of filamentous algae, blue-green algae, duckweed and watermeal in 2021 will occur at the Town of Delavan Community Park Public Beach and Public Boat Launch area because these sites are well known for having nuisance populations of these during the summer and fall. Timing of treatment will be dependent on lake and weather conditions. This program will begin the week of June 21, 2021 and be conducted two times per month until the week of August 16, 2021

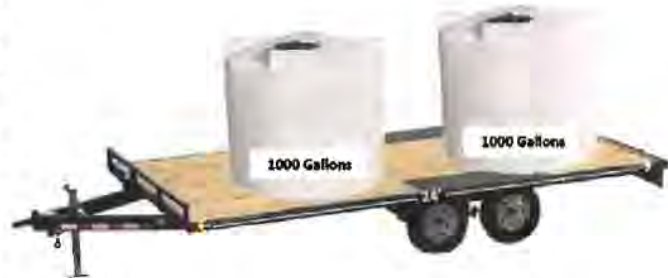
Equipment will include, one 30 foot x 10 foot barge that has been outfitted to act as a work platform and power source for a Salaroll pump in combination with a grinder pump, that will be used to suction filamentous algae, blue-green algae, duckweed and watermeal off the water surface. Suction capacity of the pump is 53 gallons per minute with a lift of 33 feet. Pump discharge capacity is 44 gallons per minute with a discharge length of 600 feet and discharge lift of 328 feet.⁴ Suctioned material will be fed into one of two 1000 gallon CRMI

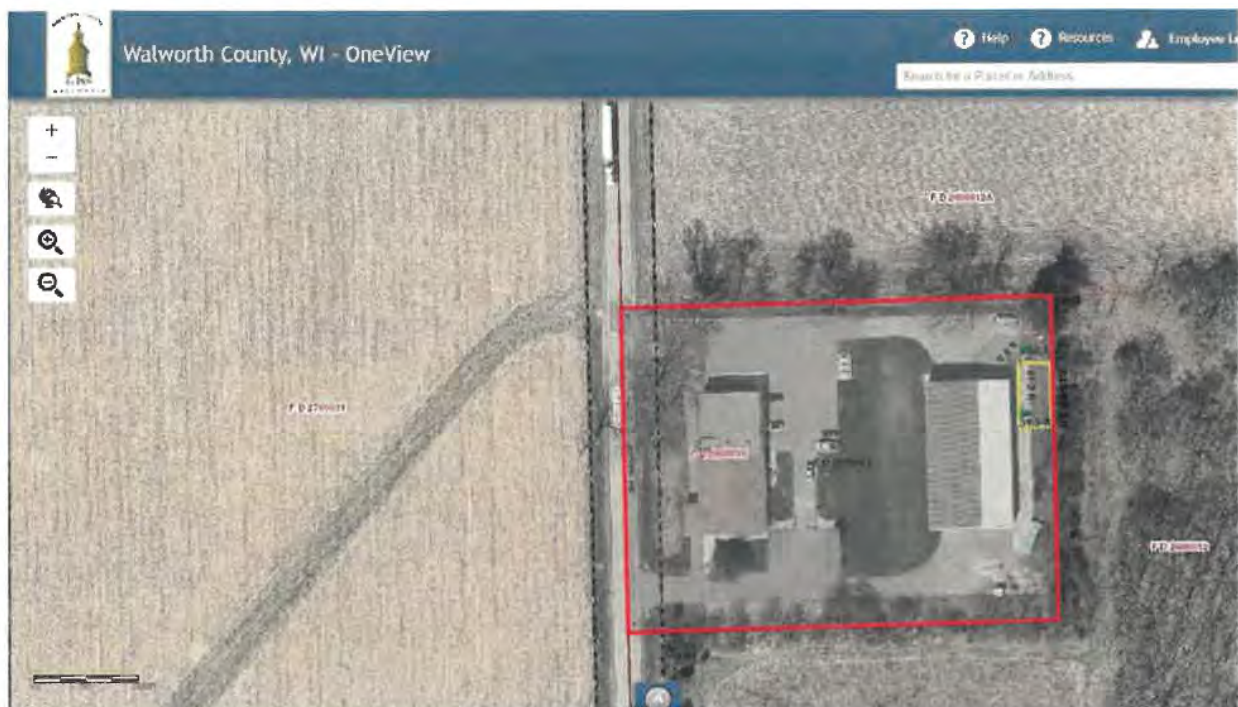
Map C.3 Location of Geotextile Dewatering Bags

Note: Proposed Dewatering Location (yellow)
 (2) Geotrax Container Tubes, 22.5' x 20.0'
 (2) 20 Mil Woven Coated PE Base Layer, 30.0' x 30.0'
